# Case Studies of Filling Movements under Buildings

G. S. Young<sup>1</sup>, BE, MEngSc, FIEAust and R. C. Blinman<sup>2</sup>, BE, MEngSc, MIEAust.

## ABSTRACT

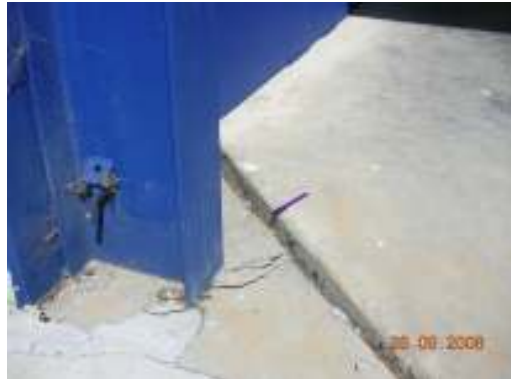
An industrial building was constructed over the filling in late 2002. By 2006, the building was showing signs of distress with relative movement of up to 50 mm between the piled building structure and ground bearing slabs (refer Figure 2).

*Figure 2: Relative movement between slab and piled column*

As the piles did not appear to have moved, it was concluded that the relative movement of the ground bearing slabs was mainly caused by the reactive clay filling swelling as a result of an increase in moisture content. The situation was exacerbated by the filling being over-compacted with a moisture content dry of optimum.

The movement is to be expected given that reactive clays swell significantly when compacted at high densities and low moisture contents (Chen 1975; Cox 1978).

As the concrete slabs were to be replaced for other non-geotechnical reasons, the recommendations for repairing the damage due to the swelling clays on site was to remove the concrete slabs, remove and replace the top 1 m depth of filling and install subsurface drainage. The replacement of the filling was to be carried out using good engineering practice and strict density and moisture control of any reactive clay used as the replacement filling.
