# Case Studies of Filling Movements under Buildings

G. S. Young<sup>1</sup>, BE, MEngSc, FIEAust and R. C. Blinman<sup>2</sup>, BE, MEngSc, MIEAust.

## ABSTRACT

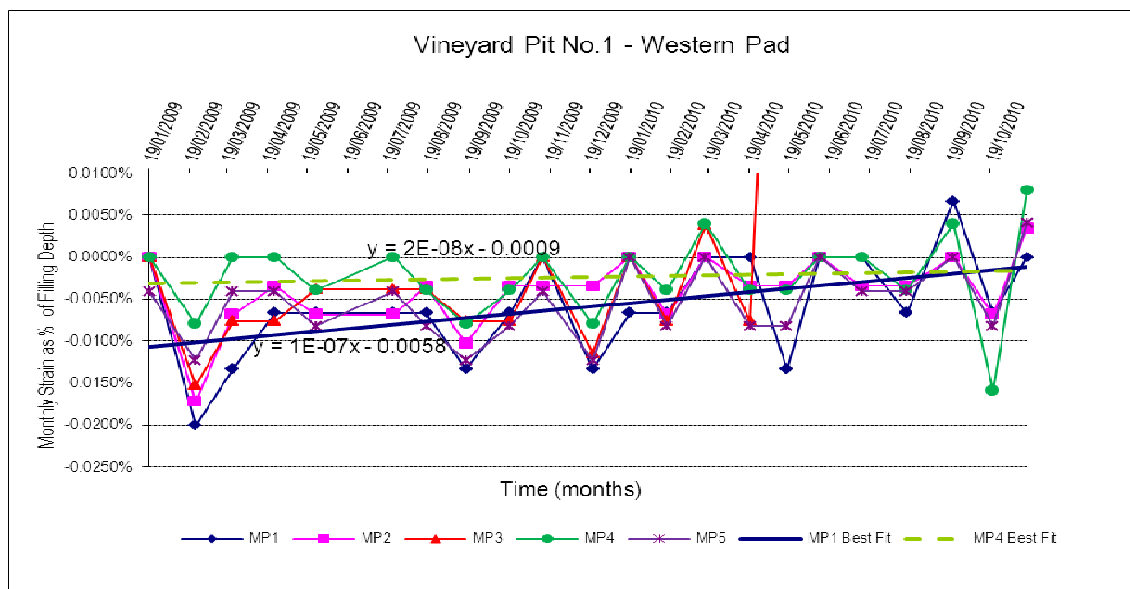
Figure 1: Percentage Strain Versus Time for Higher Western Half of Site (Area of Deepest Filling)

Settlement data was analysed to determine monthly and ongoing settlements and strains, and was plotted against time. The results were used to calculate an individual creep coefficient  $C\dot{\epsilon}$  for each monitoring point, which was then used to estimate an overall  $C\dot{\epsilon}$  for the site (typically 0.2% to 0.3%).

The results of the analyses and settlement plots were then used to forecast long term total and differential settlements over a range of design life terms. A plot of monthly strain as a percentage of filling depth versus time for all settlement monitoring points within the higher, western half of the site where filling depths were greatest is presented in Figure 1. The graph shows the line of best fit representing diminishing monthly strains as measured in terms of their percentage of filling depth.
