Newcastle Courthouse, NSW

CLIENT AAP Corporation

YEAR 2012 - 2014

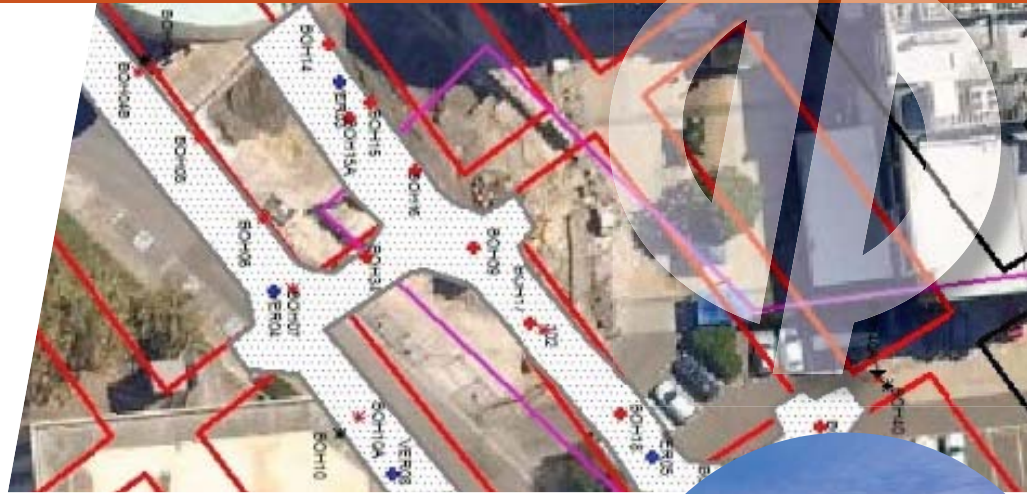
Accurate sonar mapping showing actual layout of workings

The use of ongoing sonar mapping of the workings in both seams during the works allowed variations in the layout, as compared to the the historical mine plan, to be identified early and reduced drilling requirements as well as verified that all areas of workings had been satisfactorily remediated. Careful monitoring of the grouting works allowed a refined understanding of the behaviour of grout and how it permeates through the workings.
