Design and construction of a deep soil-bentonite groundwater barrier wall at Newcastle, Australia

This paper presents geotechnical and geo-environmental aspects of the design and construction of one of the world's deepest soil bentonite (SB) groundwater barrier wall at the former Steelworks site at Newcastle, Australia. The site is undergoing a \$110 million remediation programme, and a critical part of the remediation strategy is the construction of a soil-bentonite wall, nearly 50 m deep and 1.5 km in length. This "up-gradient" cut-off wall was designed to divert groundwater around the most heavily contaminated part of the former steelworks site, known as 'Area 1'.

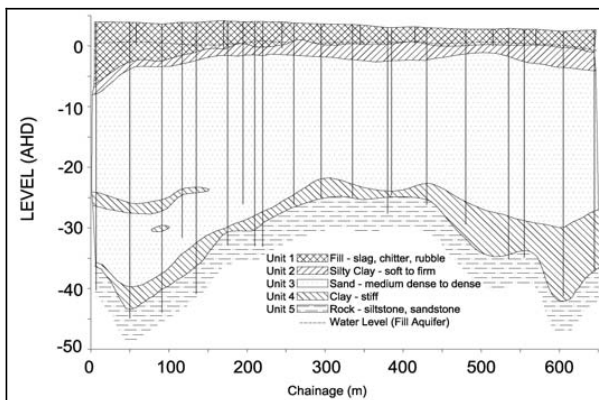
Figure 2: Cross-section Ch 0 to Ch 650

The geotechnical investigation comprised 16 test bores, 27 cone penetration tests (CPT) and 20 test pits. The bores and CPTs provided deep stratigraphic information, at an average spacing of 35 m along the wall alignment, allowing the appropriate key-in layer to be determined. The test pits provided information on the fill layer, including depth, composition, excavatability, the nature of obstructions, and the presence of contaminants in the soil or water. The typical subsurface conditions are illustrated in Figure 2, showing a section along part of the wall alignment.

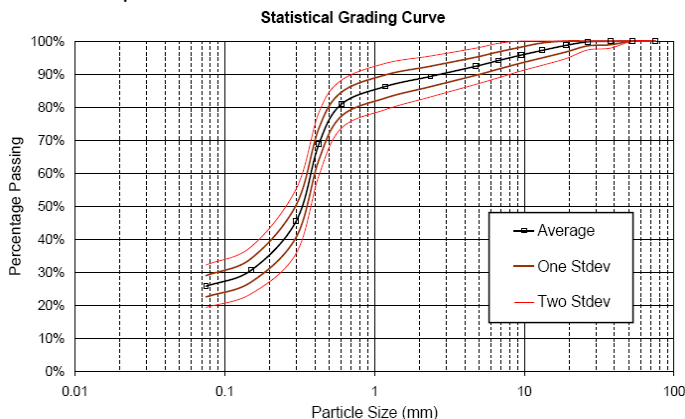
Fig. 7 - Monitoring of fines content during SBW construction (220 samples nos. taken from mixing bays)

Specific on-site testing on blended backfill material was performed daily before incorporation in the trench. It included daily fines content to verify that the minimum 20% fines (75 μ m sieve) criteria was respected, as shown on Fig. 7 which is a statistical analysis based on 220 gradations tests), slumps to check consistence and densities. In addition, mud-balance densities of in-trench backfill was monitored from samples taken at different depths (including 2m from the bottom) to check that backfill remained heavier than in-trench slurry by at least 0.25g/cm³.

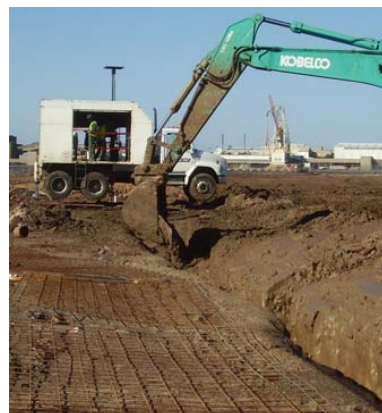
Fig. 8 - CPTu testing on top of barrier wall

As a further check of backfill uniformity and base key, 20 piezocone (CPTu) tests were carried out through the narrow width of the SB wall to the base (about 40 m), as shown in Fig 8, requiring great care to maintain verticality of the cone. This was successful and only a few tests struck the side wall of the trench. It is noted that care is required interpreting such tests because if the cone hits lumps of clay or other inclusions, it can falsely give a signature similar to a sand layer.
